Cemetery Gravestone Conservation

Before and After Photos

Hadley , MA

Completed October 2022

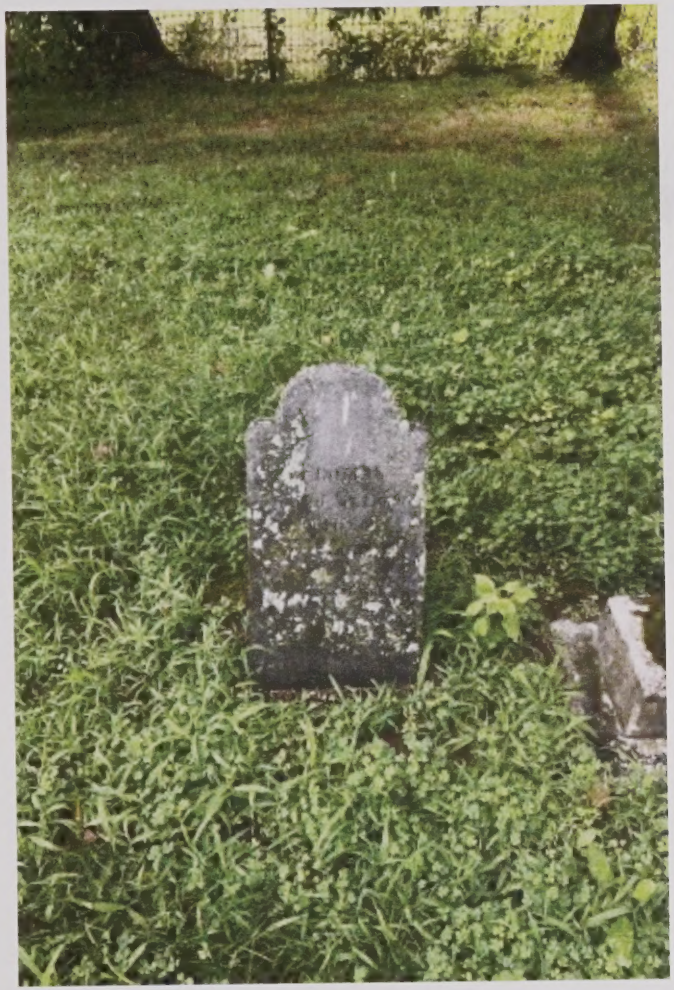
Cemetery	North Hadley Cemetery
Lot #	2
Name	Infant Billings
Material	marble
Marker Type	tablet
Stone Condition	Ambient dirt and biological growth, leaning
Treatment Methods:	Treatment with D/2 biological solution. Reset to level and plumb with 3/4 inch hard-pack.

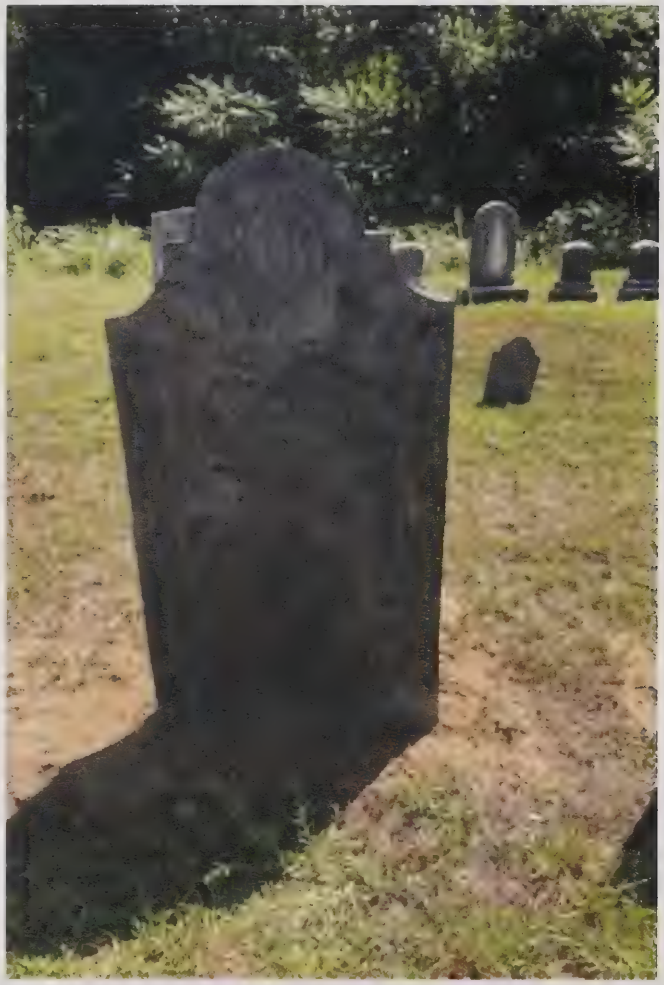
Stone Condition Ambient dirt and biological growth, leaning

Treatment Methods: Treatment with D/2 biological solution. Reset to level and plumb with 3/4 inch hard-pack.

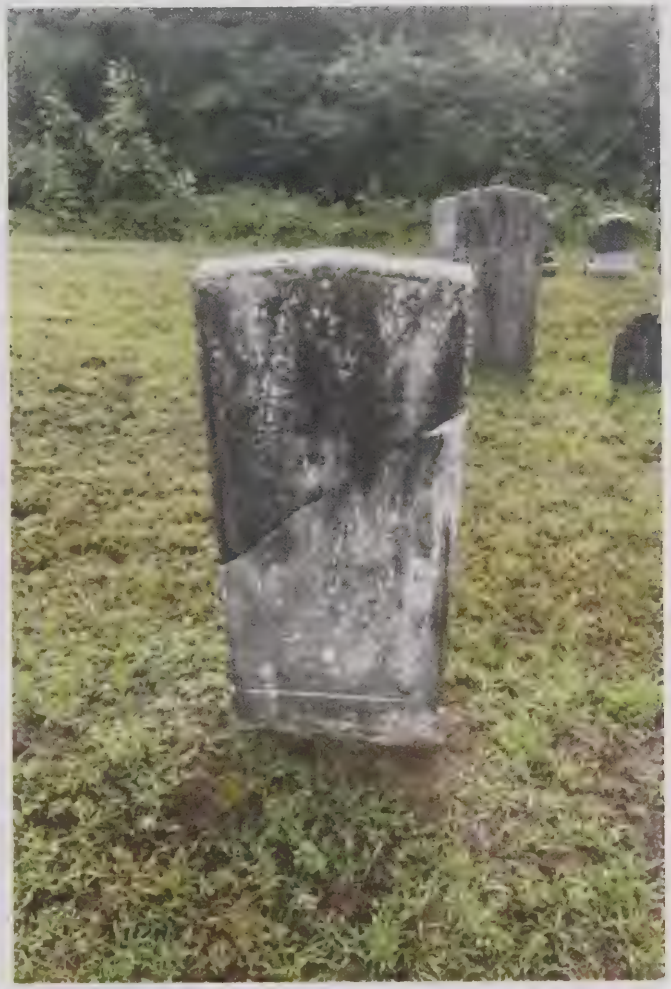
Cemetery	North Hadley Cemetery
Lot #	05~17
Name	Enoch M. Jones
Material	marble
Marker Type	tablet

Stone Condition Ambient dirt and biological growth, broken, fallen

Treatment Methods: Treatment with D/2 biological solution. Reset to level and plumb with 3/4 inch hard-pack. Adhesive repair with Akemi Akepox and infill remaining cracks with Lithomex Lime Mortar.

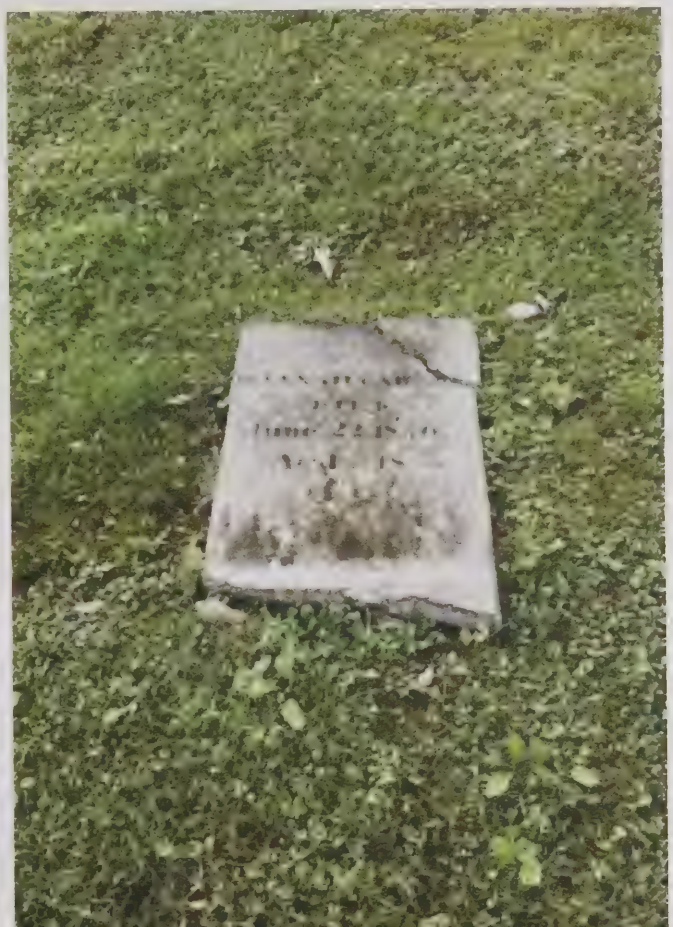
Stone Condition Ambient dirt and biological growth, broken, fallen

Treatment Methods: Treatment with D/2 biological solution. Reset to level and plumb with 3/4 inch hard-pack. Adhesive repair with Akemi Akepox and infill remaining cracks with Lithomex Lime Mortar.

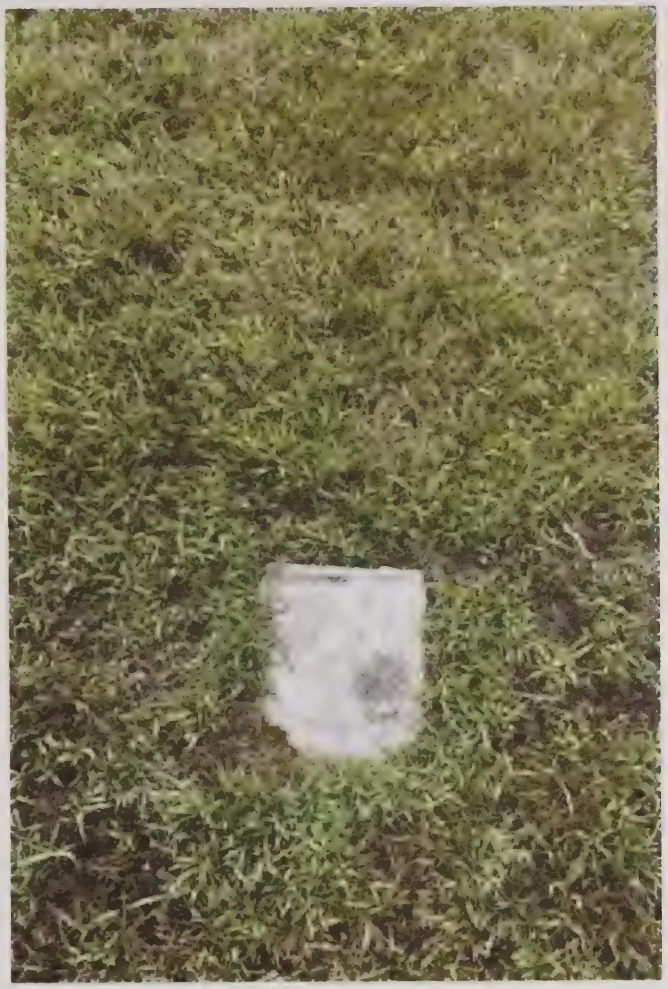
Cemetery	North Hadley Cemetery
Lot #	06~19
Name	Unknownl Smith
Material	marble
Marker Type	die in base

Stone Condition Ambient dirt and biological growth, fallen

Treatment Methods: Treatment with D/2 biological solution. Reset to level and plumb with 3/4 inch hard-pack.Secured sections with Akemi Akepox.

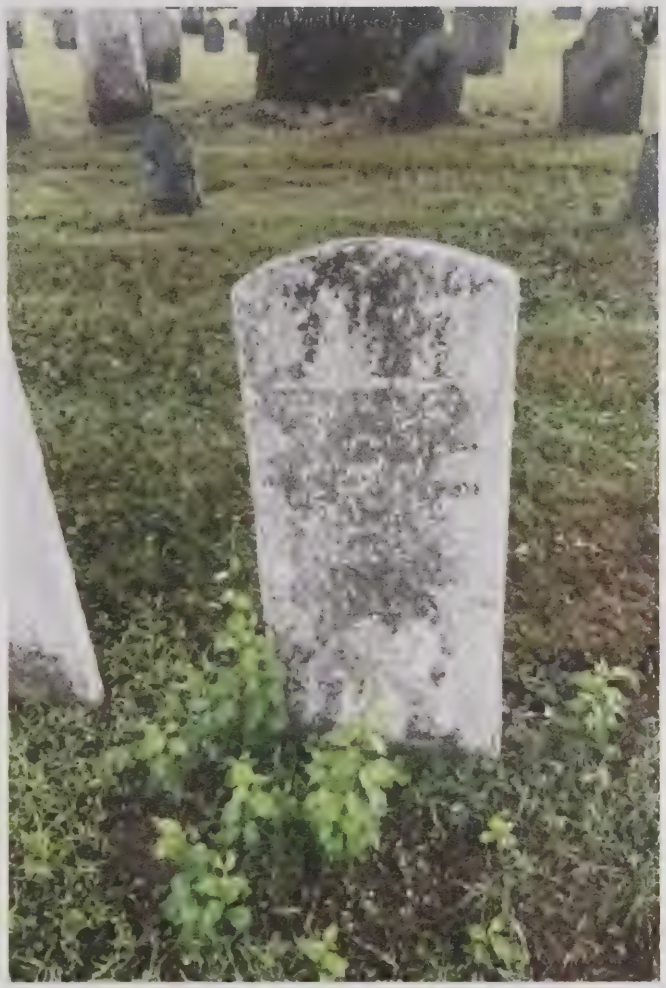
Cemetery	North Hadley Cemetery
Lot #	08~04
Name	Hannah Lamson
Material	marble
Marker Type	tablet
Stone Condition	Ambient dirt and biological growth, leaning
Treatment Methods:	Treatment with D/2 biological solution. Reset to level and plumb with 3/4 inch hard-pack.

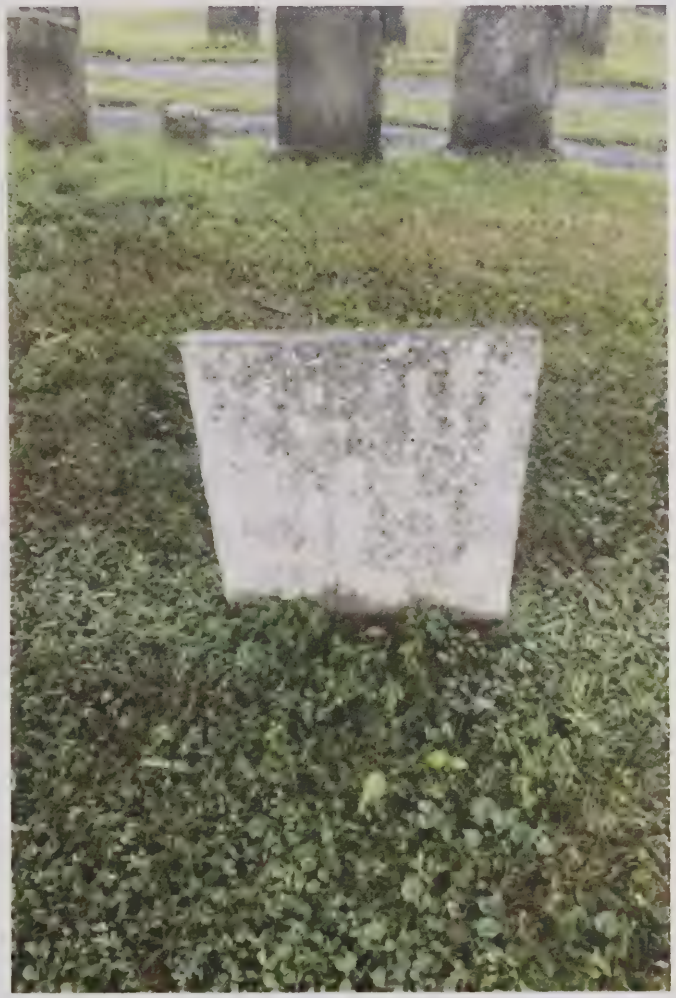
Cemetery	North Hadley Cemetery
Lot #	08~07
Name	Phua Hibbard
Material	marble
Marker Type	tablet
Stone Condition	Ambient dirt and biological growth, leaning
Treatment Methods:	Treatment with D/2 biological solution. Reset to level and plumb with 3/4 inch hard-pack.

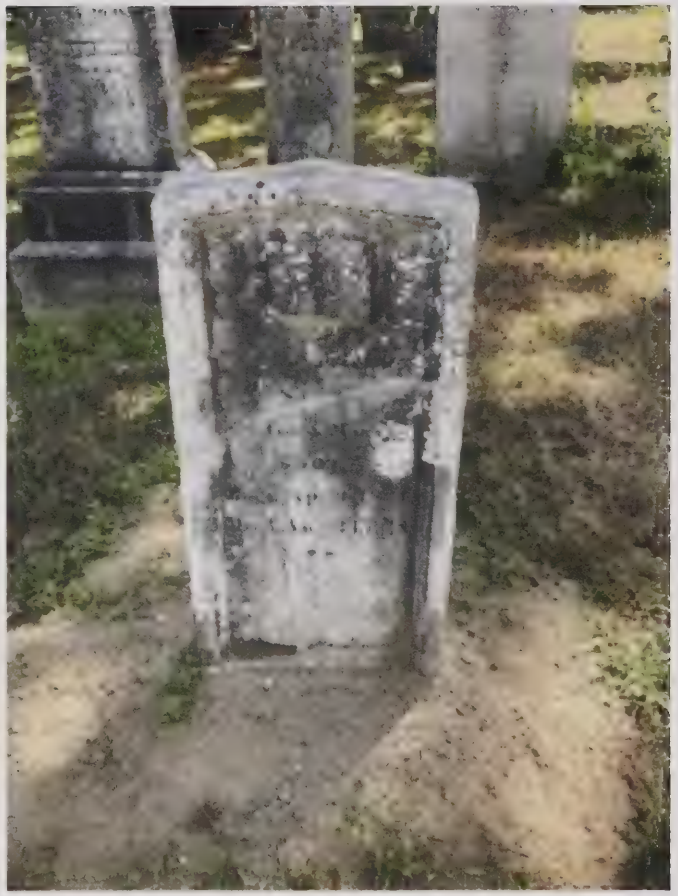
Stone Condition Ambient dirt and biological growth, broken, fallen

Treatment Methods: Treatment with D/2 biological solution. Reset to level and plumb with 3/4 inch hard-pack. Adhesive repair with Akemi Akepox and infill remaining cracks with Lithomex Lime Mortar.

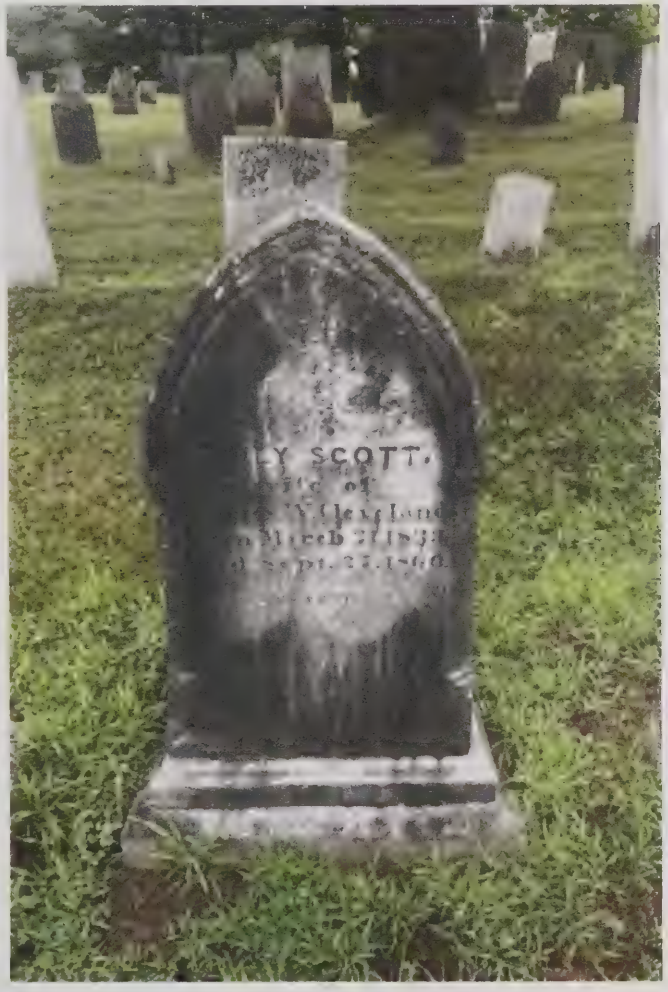
Cemetery	North Hadley Cemetery
Lot #	09~09
Name	Emily Scott Cleveland
Material	marble
Marker Type	Die on Base

Stone Condition Ambient dirt and biological growth, leaning, loose
Treatment Methods: Treatment with D/2 biological solution. Reset to level and plumb with 3/4 inch hard-pack.Secured sections with Akemi Akepox.

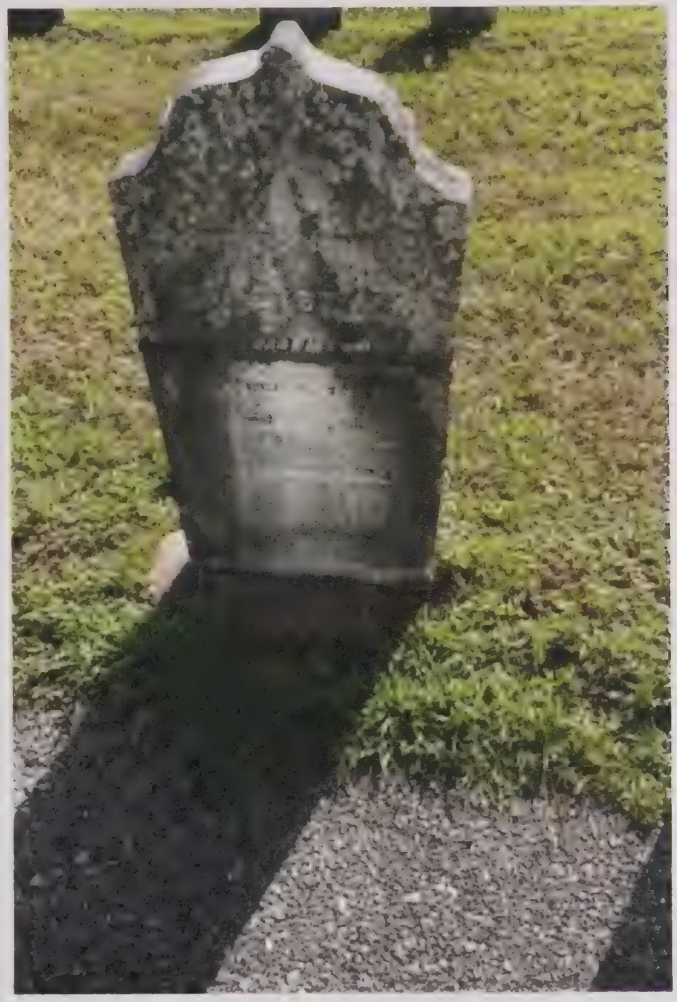
Cemetery	North Hadley Cemetery
Lot #	09~24
Name	Esther Belden
Material	marble
Marker Type	tablet in base
Stone Condition	Ambient dirt and biological growth, leaning
Treatment Methods:	Treatment with D/2 biological solution. Reset to level and plumb with 3/4 inch hard-pack.

Note: Mortar from previous repair could not be removed without causing permanent damage

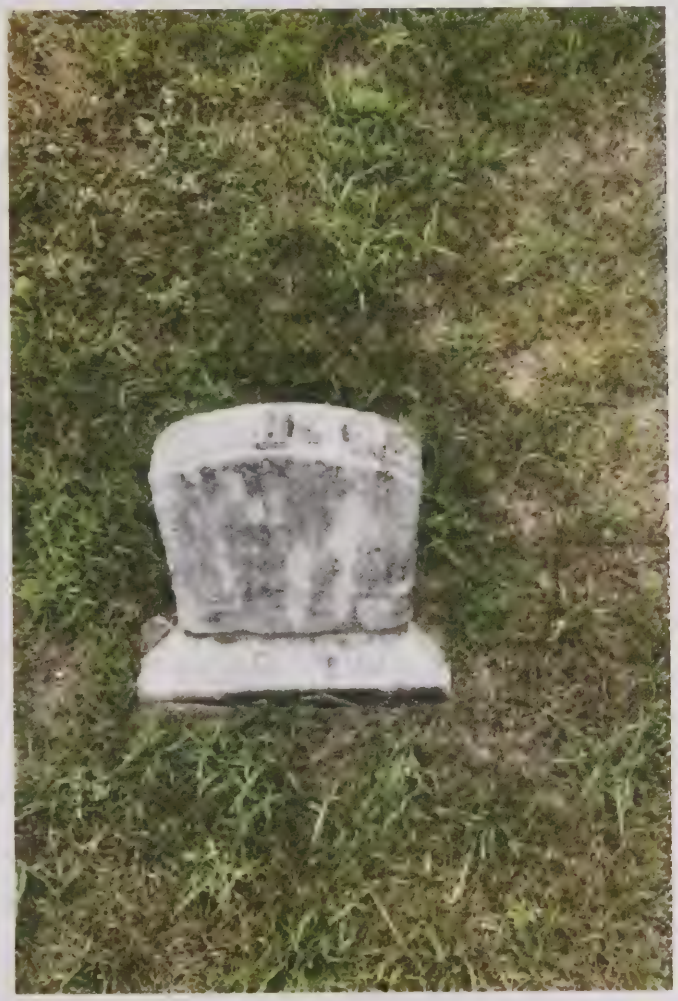
Cemetery	North Hadley Cemetery
Lot #	10~36
Name	Harriet Ware
Material	marble
Marker Type	Die on Base

Stone Condition Ambient dirt and biological growth, leaning, loose
Treatment Methods: Treatment with D/2 biological solution. Reset to level and plumb with 3/4 inch hard-pack.Secured sections with Akemi Akepox.

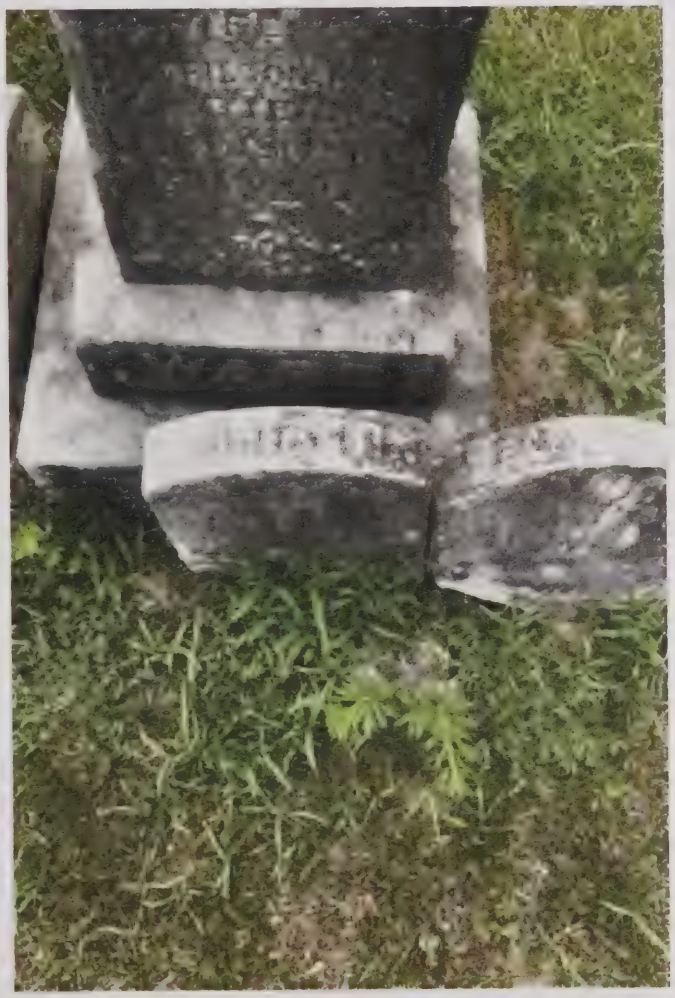
Cemetery	North Hadley Cemetery
Lot #	10~37
Name	Lauriston Ware
Material	marble
Marker Type	Die on Base

Stone Condition Ambient dirt and biological growth, leaning, loose
Treatment Methods: Treatment with D/2 biological solution. Reset to level and plumb with 3/4 inch hard-pack.Secured sections with Akemi Akepox. Infilled cracks with Lithomex Lime mortar

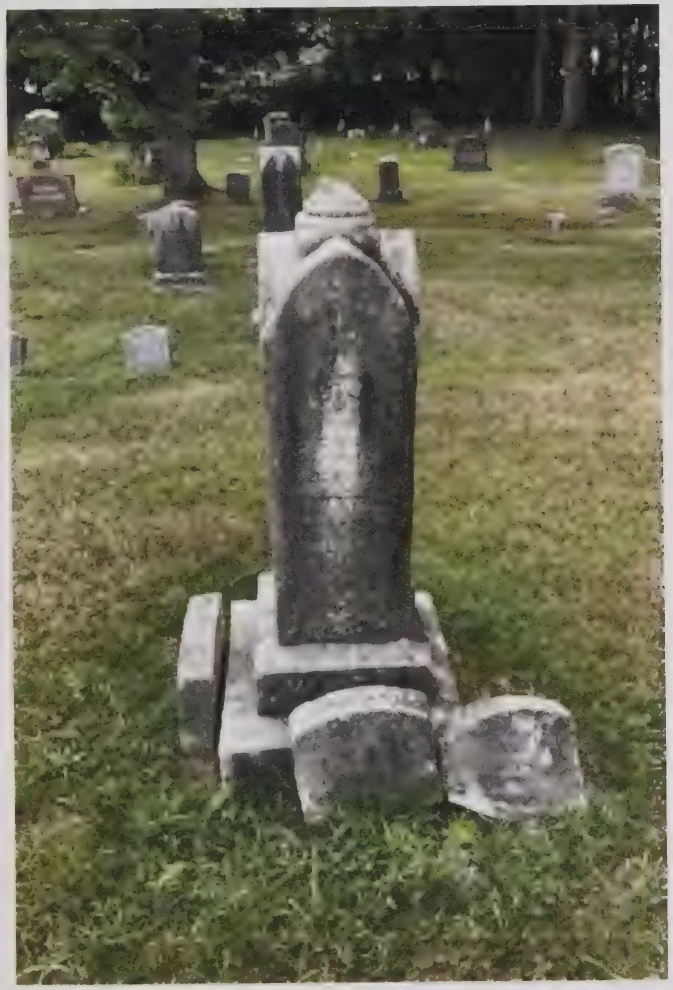
Cemetery	North Hadley Cemetery
Lot #	√
Name	Ware
Material	marble
Marker Type	obelisk

Stone Condition Ambient dirt and biological growth, leaning, loose
Treatment Methods: Treatment with D/2 biological solution. Reset to level and plumb with 3/4 inch hard-pack.Secured sections with Akemi Akepox.

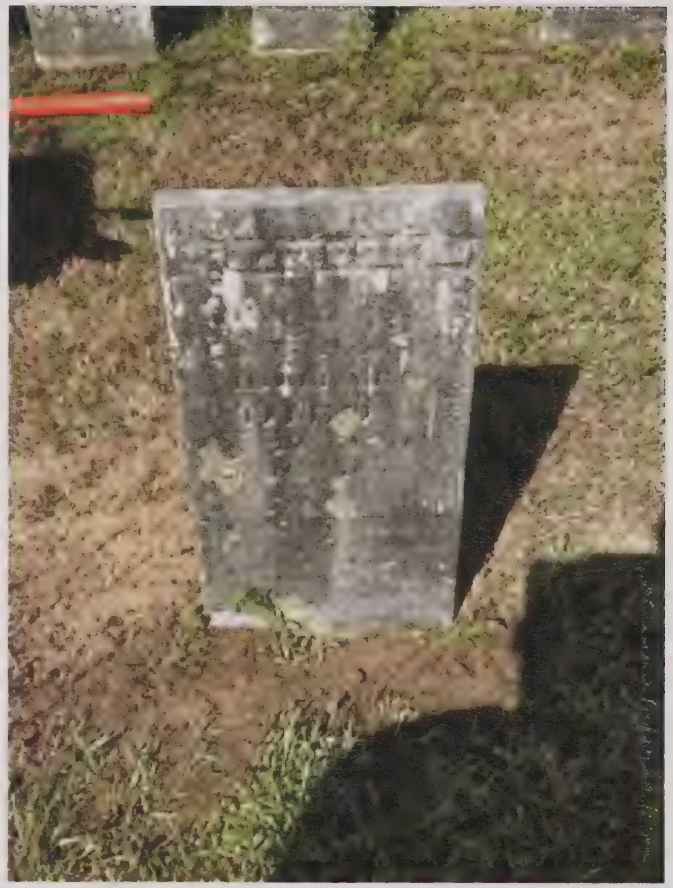
Stone Condition Ambient dirt and biological growth, leaning

Treatment Methods: Treatment with D/2 biological solution. Reset to level and plumb with 3/4 inch hard-pack.

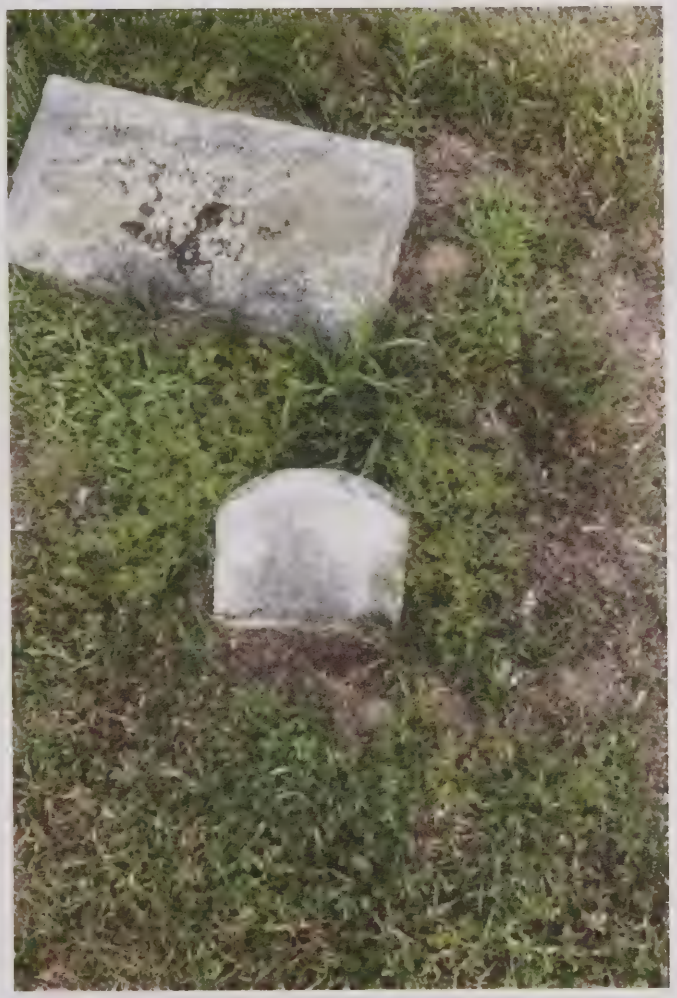
Cemetery	North Hadley Cemetery
Lot #	12~37
Name	Father Comins
Material	marble
Marker Type	tablet on base
Stone Condition	Ambient dirt and biological growth, leaning
Treatment Methods:	Treatment with D/2 biological solution. Reset to level and plumb with 3/4 inch hard-pack.

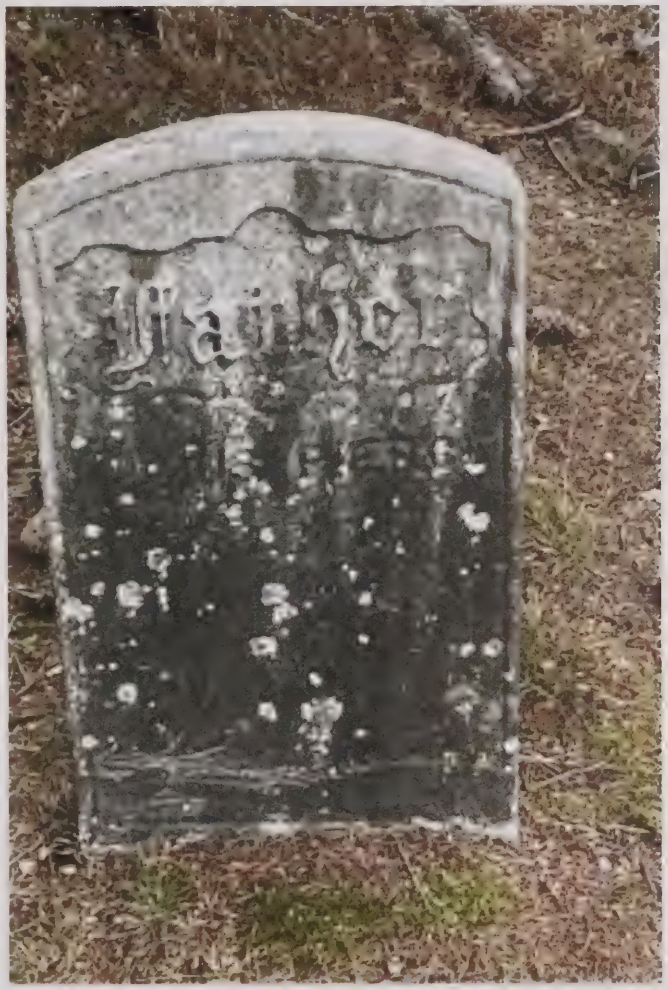
Cemetery	North Hadley Cemetery
Lot #	13~04
Name	Lucius Pierce
Material	marble
Marker Type	tablet on Base

Stone Condition Ambient dirt and biological growth, leaning, loose
Treatment Methods: Treatment with D/2 biological solution. Reset to level and plumb with 3/4 inch hard-pack.Secured sections with Akemi Akepox.

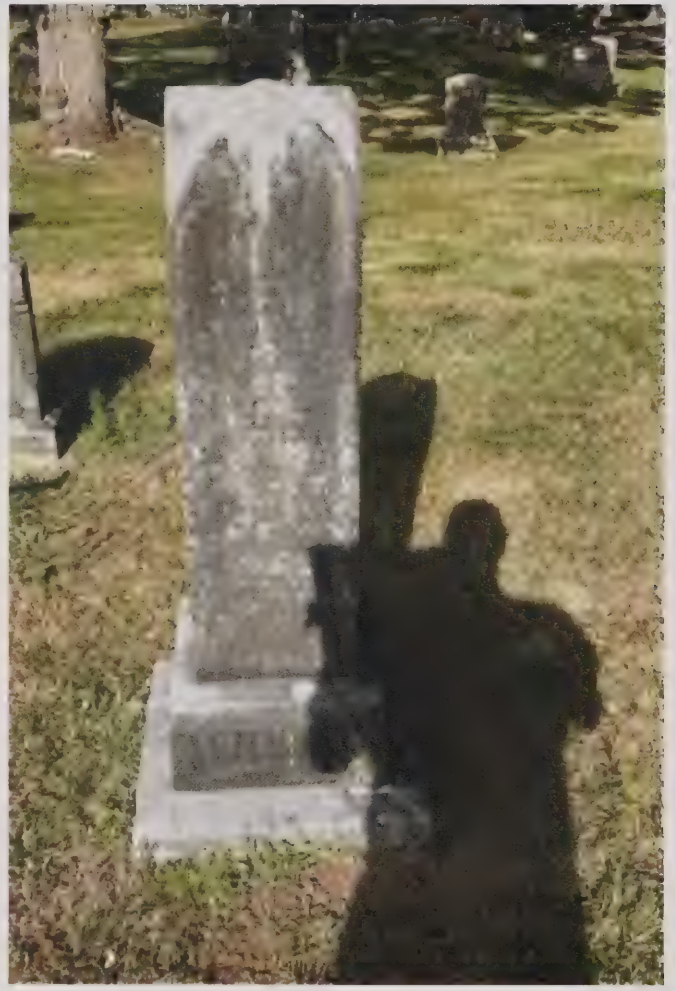
Cemetery	North Hadley Cemetery
Lot #	13~34
Name	Tuttle
Material	marble
Marker Type	pedestal
Stone Condition	Ambient dirt and biological growth, leaning
Treatment Methods:	Treatment with D/2 biological solution. Reset to level and plumb with 3/4 inch hard-pack.

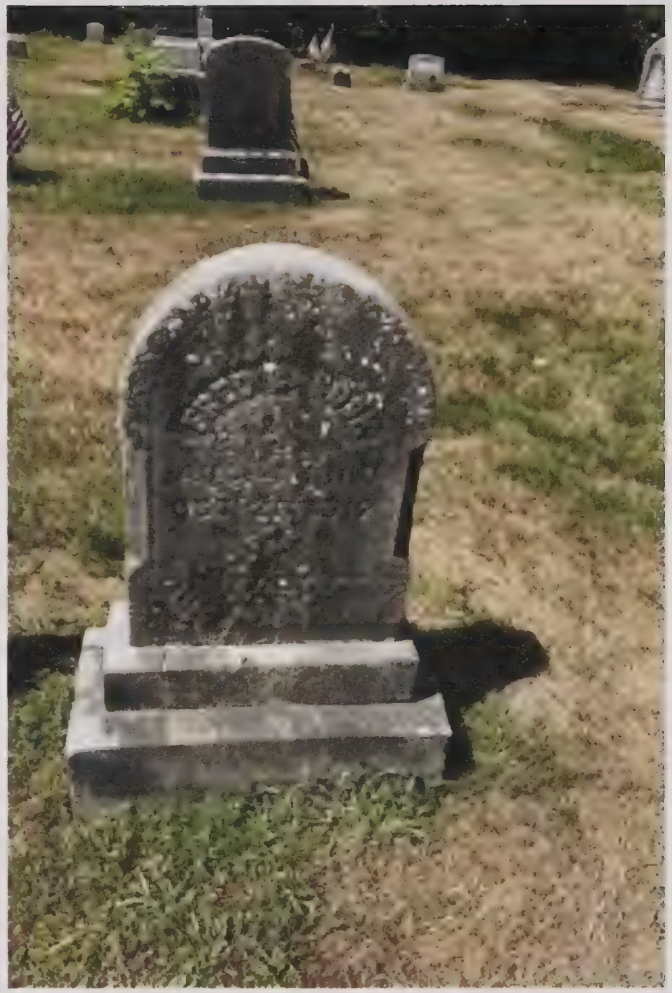
Cemetery	North Hadley Cemetery
Lot #	18~15
Name	Fred Cook
Material	marble
Marker Type	Die on Base

Stone Condition Ambient dirt and biological growth, leaning, loose
Treatment Methods: Treatment with D/2 biological solution. Reset to level and plumb with 3/4 inch hard-pack.Secured sections with Akemi Akepox.
